# ESP32-S3 Series SoC

## Errata

This document describes known errata in ESP32-S3 series of SoCs.

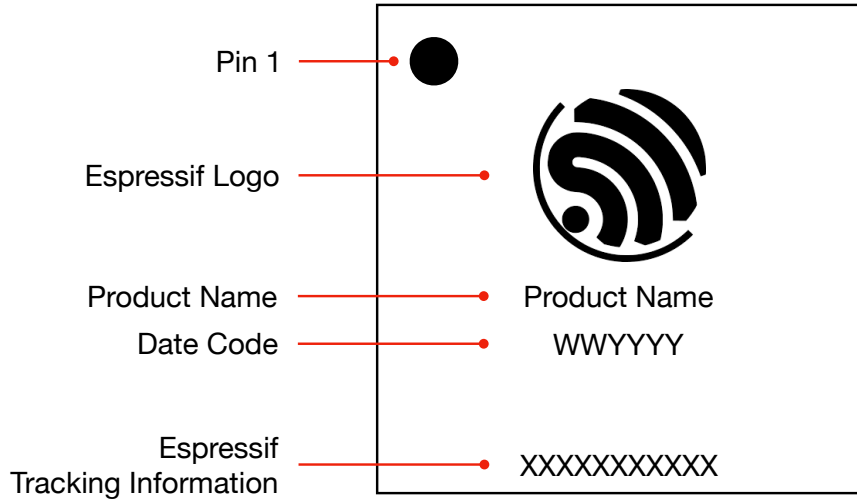
Figure 1: Chip Marking Diagram

- **Espressif Tracking Information** line in chip marking

Chip Revision	Espressif Tracking Information
v0.0	xAxxxxxx
v0.1	xBxxxxxx
v0.2	xCxxxxxx

In this case, the chip may be identified by **Date Code** in chip marking (see Figure 1). For more information, please refer to [Espressif Chip Packaging Information](#).

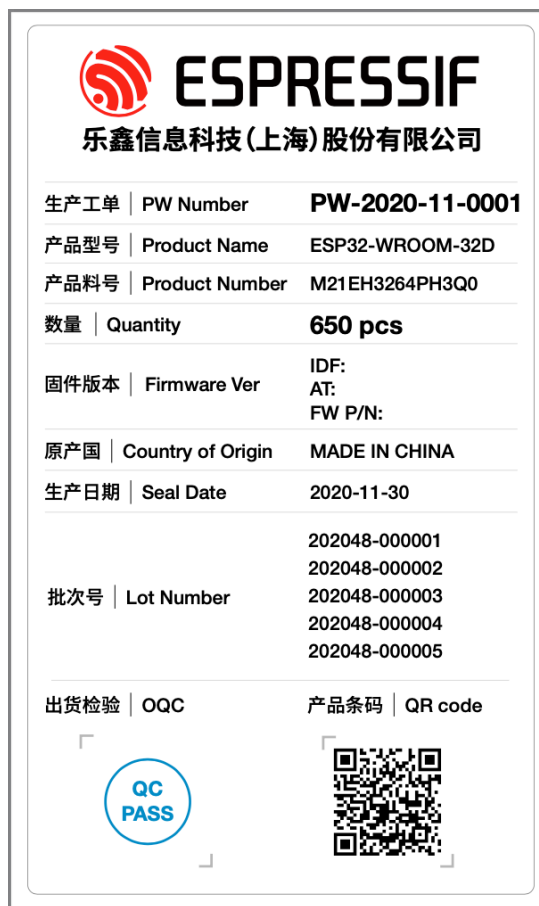
Figure 3: Module Product Label

Modules built around the chip may be identified by **PW Number** in product label (see Figure 3). For more information, please refer to [Espressif Module Packaging Information](#).

Please note that **PW Number** is only provided for reels packaged in aluminum moisture barrier bags (MBB).
