ESP32 Series SoC

Errata

Version 2.7
Espressif Systems
Copyright © 2023

This document details hardware errata and workarounds in the ESP32.

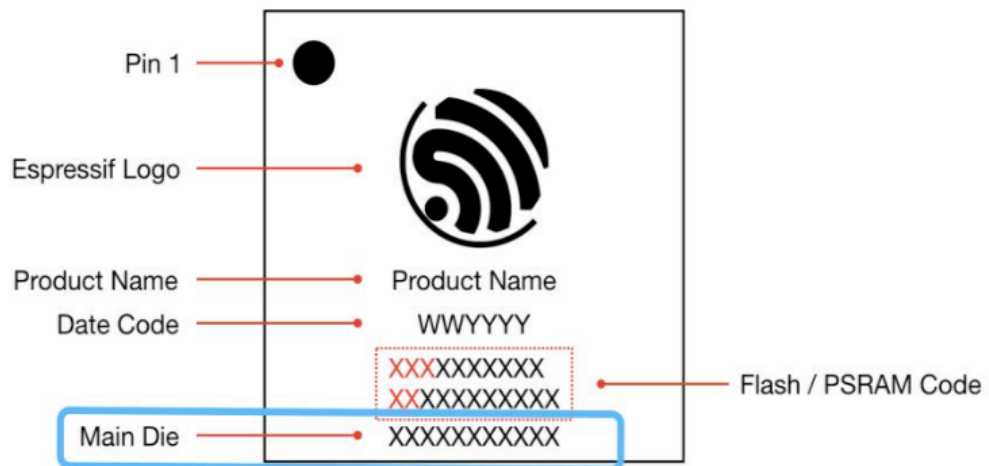
Figure 1-1: Chip Marking Diagram

- **Main Die** line in chip marking, see the figure below.

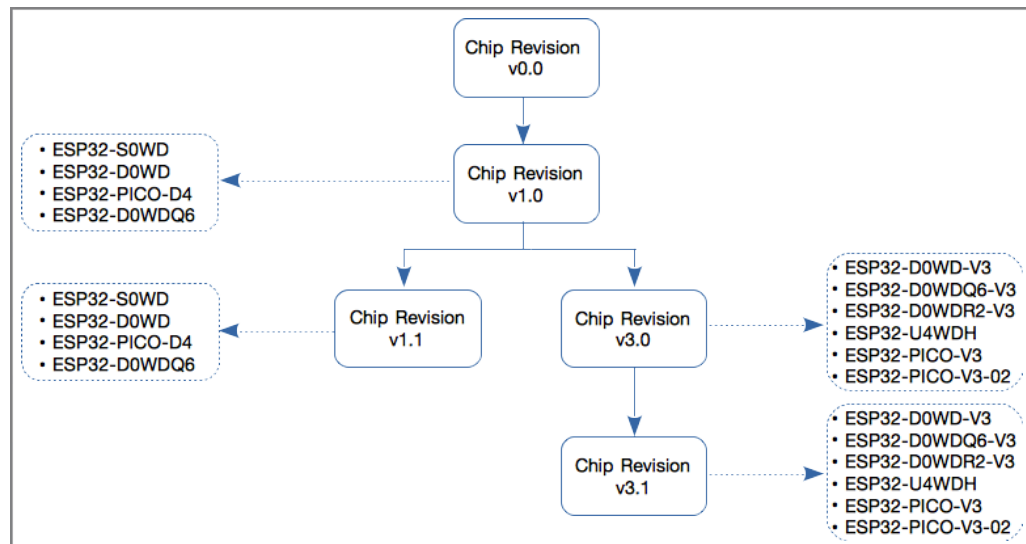
Figure 1-2: Chip Revisions and Chip Variants

The figure below shows the relation between chip revisions and chip variants.

- ESP32-S0WD, ESP32-D0WD, ESP32-PICO-D4, and ESP32-D0WDQ6 will be produced with chip revision v1.1 inside, see [PCN20220901](#).
- ESP32-D0WD-V3, ESP32-D0WDQ6-V3, ESP32-D0WDR2-V3, ESP32-U4WDH, ESP32-PICO-V3, and ESP32-PICO-V3-02 will be produced with chip revision v3.1 inside, see [PCN20220901](#).
